CONNECTICUT
DEPARTMENT
OF
TRANSPORTATION

CONDITION INSPECTION
FOR THE
DERBY / SHELTON STATION

**CONN. DEPT OF TRANSPORTATION
STATION INSPECTION**

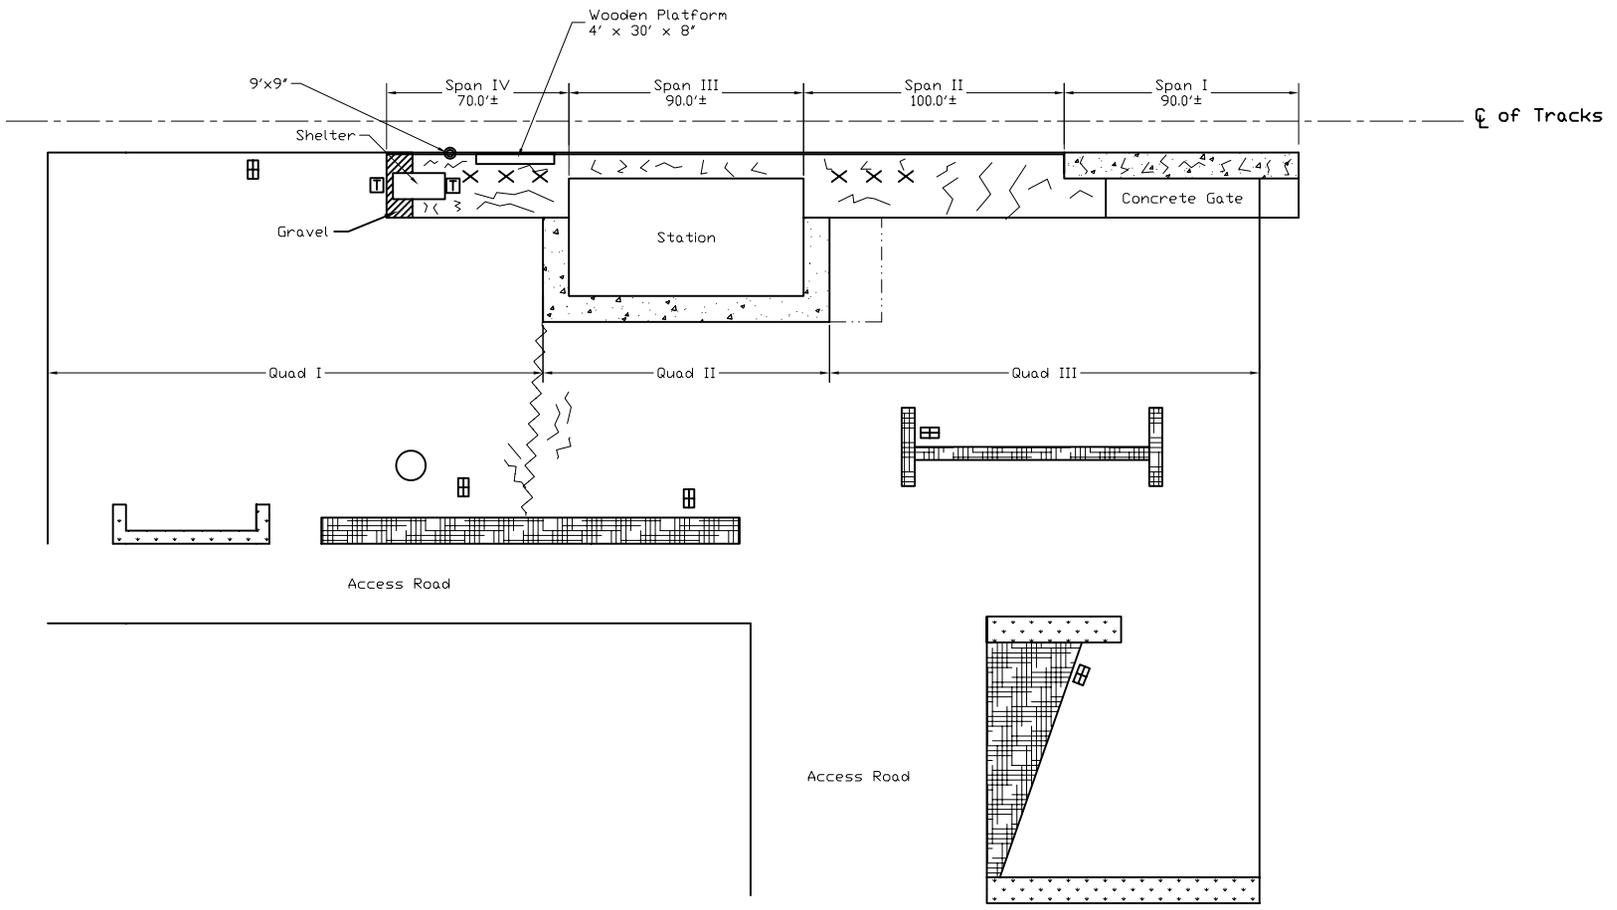
Urbitran Associates, Inc.
Connecticut Dept. of Transportation
Derby/Shelton Station General Plan
Date: 11-19-01

1. On the eastside of Span II-IV the surface is uneven by 2' in depth and 9' wide.

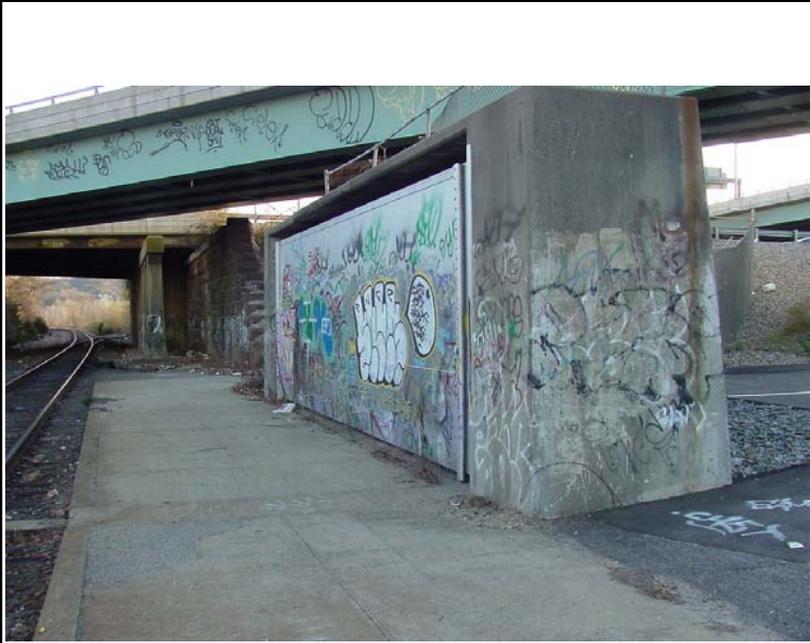
PHOTO NO. 9

Description:
The concrete sidewalk
is cracked; graffiti is
present throughout the
concrete gate.

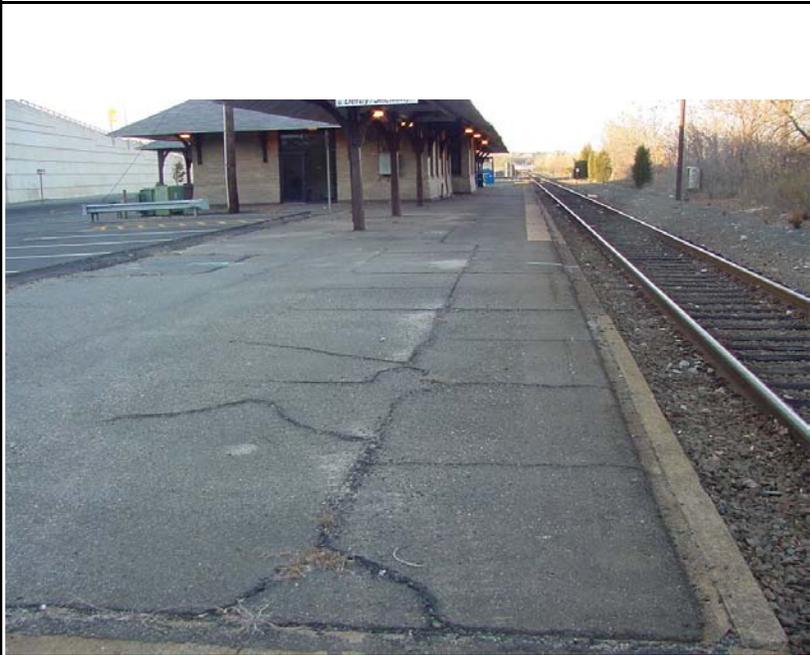
PHOTO NO. 10

Description:
The asphalt surface
is cracked

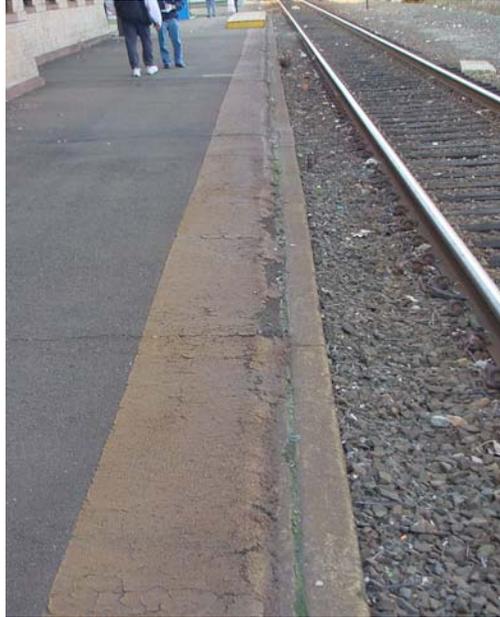
PHOTO NO. 11

Lead-Based Paint was found on surfaces noted above. Painted platform warning strip was found to be in poor condition. Other painted surfaces were found to be in fair to good condition. Any future disturbance of the lead-based painted surfaces noted above should be abated by an Environmental Protection Agency/Connecticut Abatement Contractor in accordance with the EPA's 40 CFR 745, HUD's 24 CFR Part 35 and The HUD Guidelines for the Evaluation and Control of Lead-Based Paint Hazards in Housing, OSHA's 29 CFR 1926.62, and all other applicable regulations.

Description: The warning strip is fading and there is a drop in elevation of 2" between the platform curb and the asphalt platform

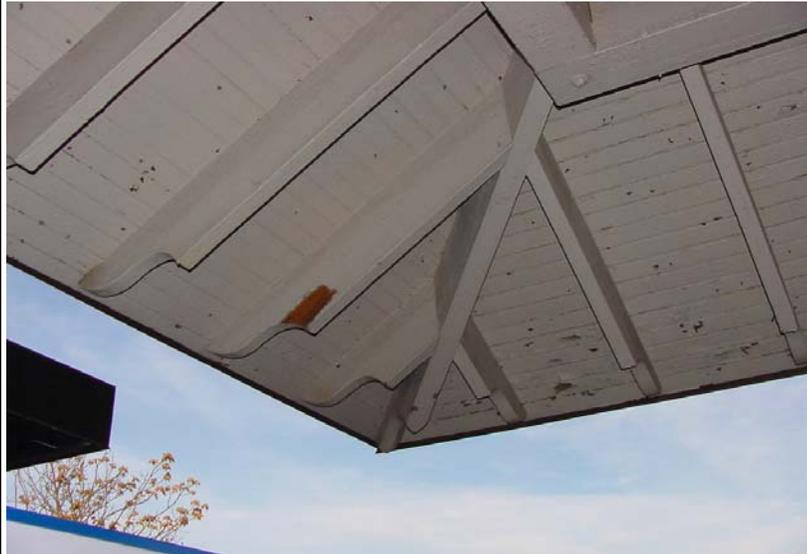
PHOTO NO. 12

Description: The paint on the underside of the canopy roof is chipped

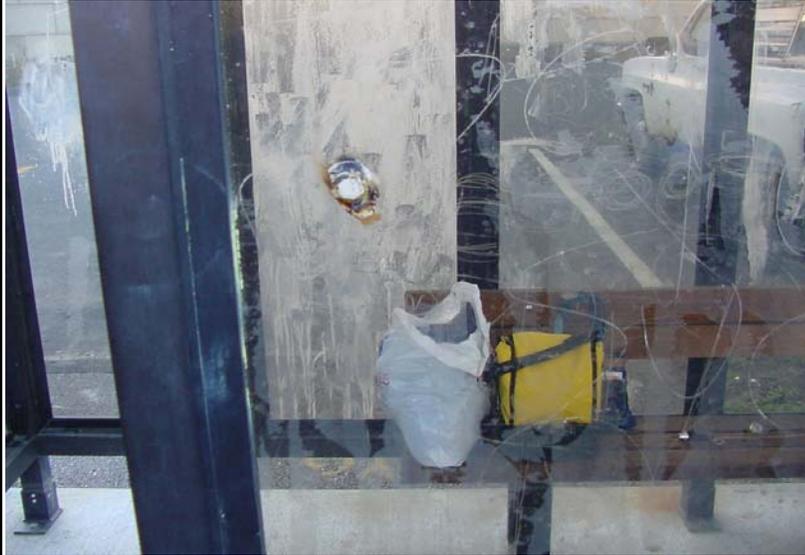
PHOTO NO. 13

Description: Burnt holes and scratches are present in the windows of the shelter

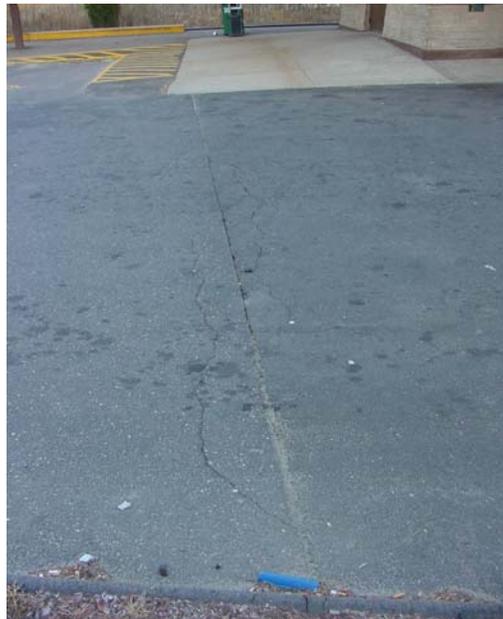
PHOTO NO. 14

Description: A asphalt crack extends the width of Quad II

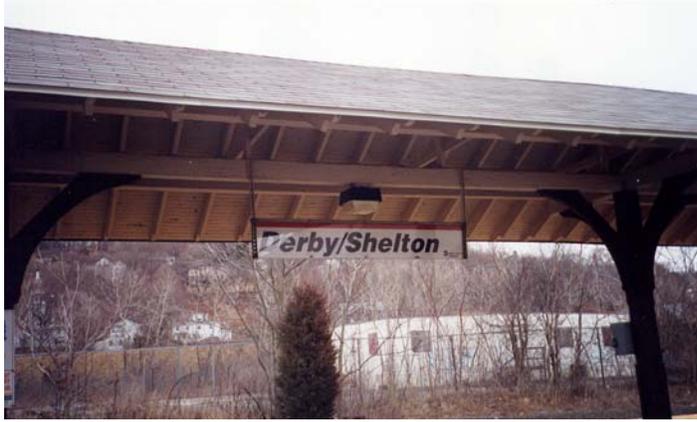
PHOTO NO. 15

Remarks: A typical section of the platform was measured at the location indicated and found to average
18.8 fc.
The platform luminaires appear to be operating satisfactory, but the lenses are yellowing.

Description:
platform lighting

The IESNA recommends lighting levels to average at least five foot-candles for railroad station platforms and this station platform measured 18.8 foot-candles. Although light levels exceed the minimum, the light fixture lenses are discoloring because of the lamps heat, ultra violet rays from the sun, and the lamps ultra violet. This discoloration is reducing the light level of the fixtures and also reducing the physical strength of the lens against vandalism. We recommend that the lenses of the fixture be replaced to better replicate the characteristics of the manufacturers' design.

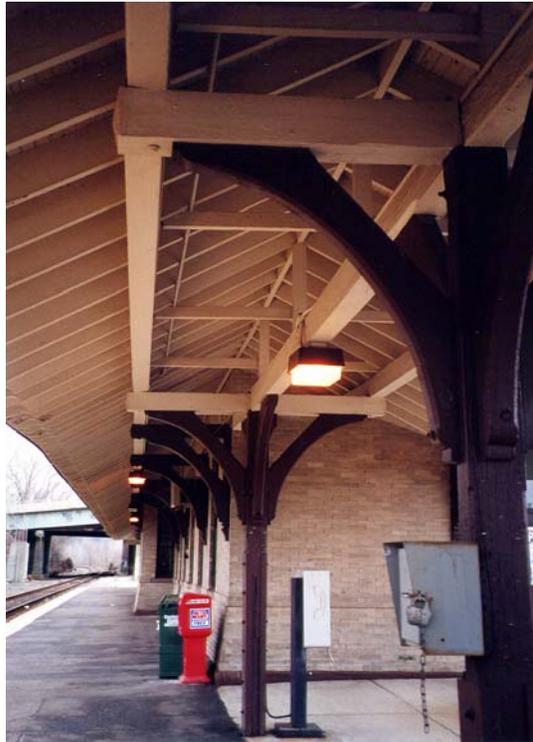
PHOTO NO. 16

Description:
platform lighting

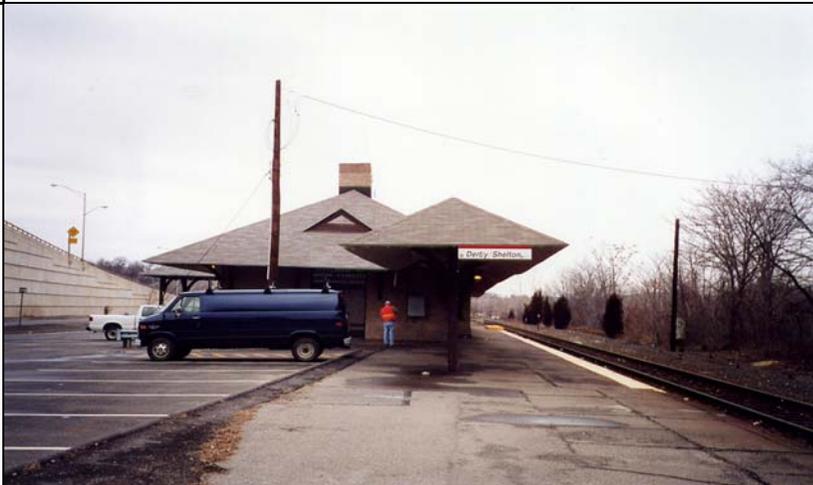
PHOTO NO. 18

Description:
View of platform,
no gutters or
downspouts on
canopy

The task at the Derby/Shelton station was to inspect only the platform. There are no gutters or downspouts on the platform canopy. Gutters and downspouts should be installed.
